Fatigue on engine pistons – A compendium of case studies

Abstract

This work is concerned only with the analysis of fatigue-damaged pistons. Pistons from petrol and diesel engines, from automobiles, motorcycles and trains will be analyzed. Damages initiated at the crown, ring grooves, pin holes and skirt are assessed. A compendium of case studies of fatigue-damaged pistons is presented. An analysis of both thermal fatigue and mechanical fatigue damages is presented and analyzed in this work.

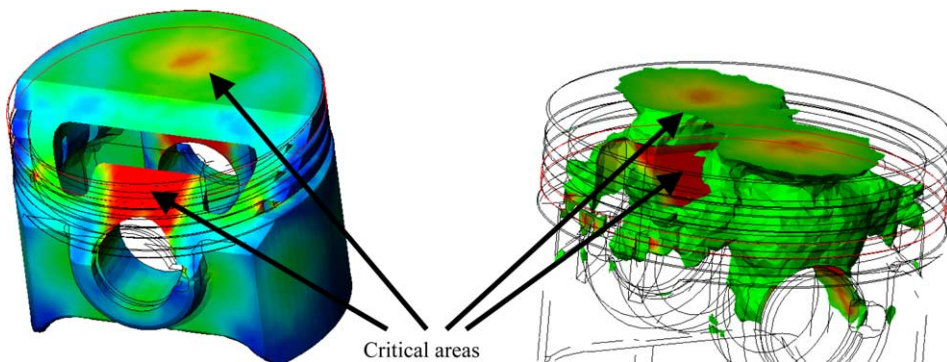
Although stresses on pistons change with piston geometries and engine pressures, Figs. 1 and 2 show a typical stress distribution on an engine piston. In Figs. 1 and 2 pressures are merely indicative and are used only with the purpose of determination of the most stressed areas. It is not intended to determine the real stresses acting on the piston. The dynamic and thermal stresses are not also included in Figs. 1 and 2.

It is clear that there are mainly two critical areas: the top side of piston pin hole and two areas at the piston head. Stress analyses on diesel pistons show the same critical areas. If holes or grooves are introduced on the pin hole it is possible to introduce critical stressed areas on those discontinuities.

Fig. 2. Typical stress distribution on an engine piston.

As observed in Figs. 1 and 2, due to the pressure at the piston head, there are mainly two critical areas: piston pin holes and localized areas at the piston head. Subsequently will be presented different engine pistons where the cracks initiated on those areas.

Mechanical fatigue damages at piston head and piston pin holes is the reason of several damaged engine pistons. Static stresses concentrate mainly at pin holes (Figs. 2 and 6) both for petrol and diesel pistons, as well as for automotive, train, and other engine fields. This explains cracks initiated at piston pin holes (Fig. 3). However, if the critical stress is at the piston pin holes why some of the pistons start their cracks at the head, as presented in Figs. 4 and 5? A metallographic study was made in piston of Fig. 5 to see if there was a special reason for that the crack initiated there (such as pores or microstructural defects) and nothing was detected. The reason for the crack to initiate at that point at the piston rim area may be related to two different aspects:

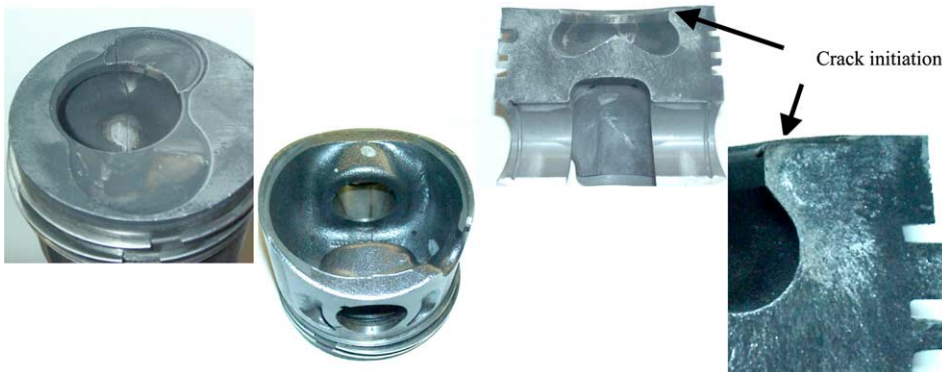
On piston in Fig. 3 it seems by fractographic analysis that the crack initiated at the pin-hole. On pistons in Figs. 4 and 5 the crack initiated on the piston head near the combustion chamber.

Fig. 5. Diesel engine piston with a crack from one side of the pin hole to the other pin hole going through the head of the piston.

- *Mechanical fatigue*: The crack always initiate at the same points – at the same vertical plane that contains the pin holes (see Figs. 4 and 5). The stresses at the piston head are higher at those areas (Fig. 6). In pistons of Figs. 4 and 5, both broken by the piston head, there is only one visible crack, and this is typical of mechanical fatigue. In Ref. [19] there is a description of a piston with only one crack, similar to those in Figs. 4 and 5, and the crack was attributed to thermal fatigue. Thermal fatigue does not seem to be the reason for these cracks because thermal fatigue produces more than one visible crack and mostly several visible cracks (see Figs. 11(a) and (b)). However, the reason why the crack initiated at the head instead of the pin hole, where the stresses are higher, is not answered yet. The reason may be on temperature.

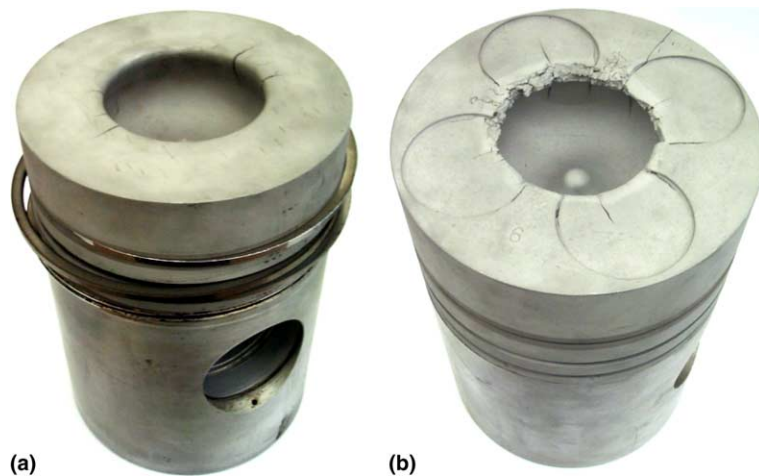
Thermal fatigue is related to the stresses in the material induced by thermal gradients in the component. Fig. 11 shows two train pistons with several cracks at the piston head.

Fig. 11. Train engine pistons with damaged head: (a) piston 1; (b) piston 2.

It seems that there is no other plausible explanation for cracks shown in Fig. 11.

In Fig. 11(b) there are cracks distributed along the bowl rim and it seems clear that the main mechanism was thermal fatigue due to an homogeneous temperature distribution. In Fig. 11(a) there are several cracks located in opposite sides at the piston crown. If they were high temperature mechanical fatigue cracks it would be only one crack and the crack would be located at the vertical plane that contains the pin holes. That is not the case – cracks are located on a different plane.

As referred before, it may be considered two ways through which thermal gradients act on stresses: thermal stresses due to the vertical distribution of the temperature along the piston – high temperatures at the top and lower temperatures at the bottom (Fig. 13(a)); and thermal stresses due to the different temperatures at the head of the piston due to the flow of the hot air or fuel impingement (Fig. 13(b)). On the first case it would be expected several fatigue radial cracks over the whole piston head. On the second case it would be expected fatigue cracks in specific areas of the piston head (those where the thermal gradients occur). Fig. 11(b) is representative of the first case while Fig. 11(a) seems to be representative of the second case.
